LOT 2 COCHRANE ROAD, CADOUX, WA, 6466
APPROVED UPGRADES & ADDITIONS TO CBH'S EXISTING GRAIN HANDLING &
STORAGE FACILITY IN CADOUX (A1600/P490)

Project: CBH- Cadoux Grain Facility Proposed Upgrade

Author: Richard Jois
Date: 10/06/21
Reference: 100621_01

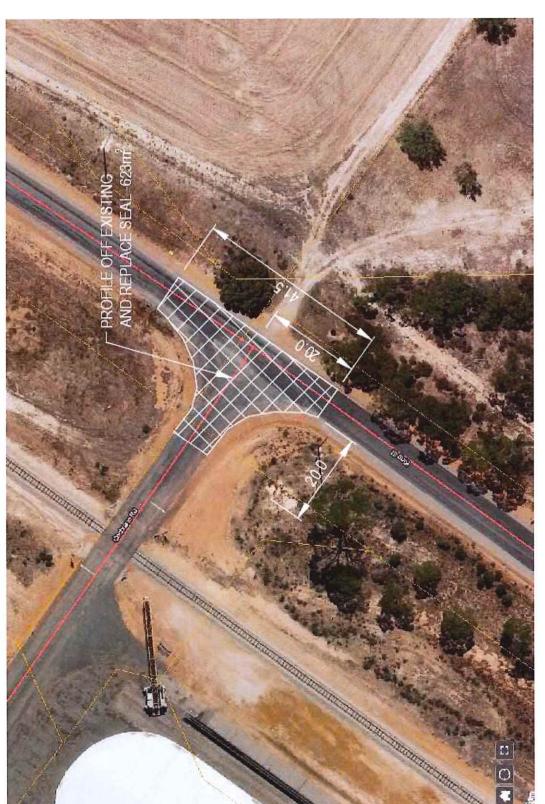
Figure 2: Site Exit at Cochrane Rd & King St intersection – Estimated Area of Seal Defects

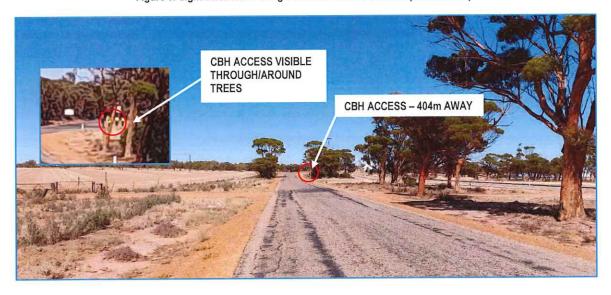
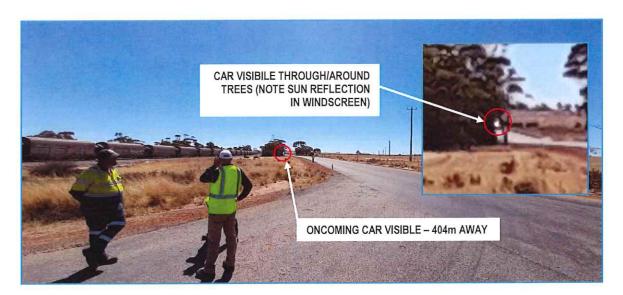
Towards the north, there is a minor obstruction to the sight line caused by the trunk of a tree. Refer to **Figure 7** and **Figure 8** which shows that the tree trunk is not wide enough to fully obscure the view of the car or the intersection, and there is a completely clear line of sight available immediately after the tree is passed.

Figure 7: Approach Vehicle Sight Distance Looking from North to CBH Access

Figure 8: Sight Distance Looking from CBH Access to North

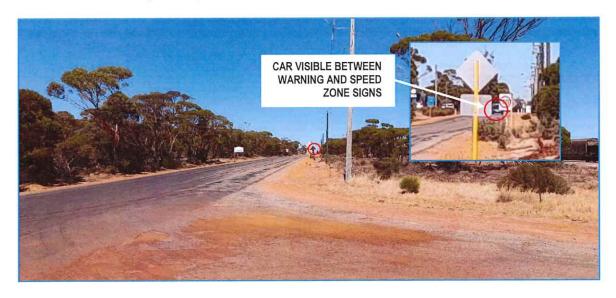
² Partially obstructed by road signage. Refer Figure 11 which shows and intermediate view 284m from the site access.

Figure 11: Sight Distance Looking from CBH Access to South (intermediate)

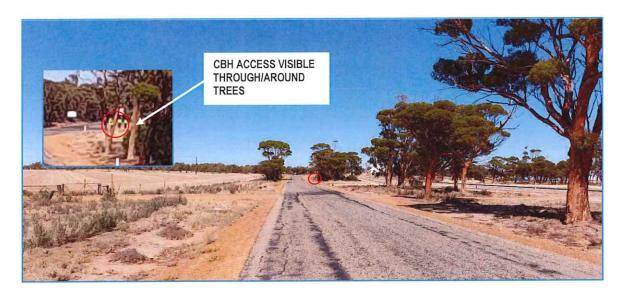
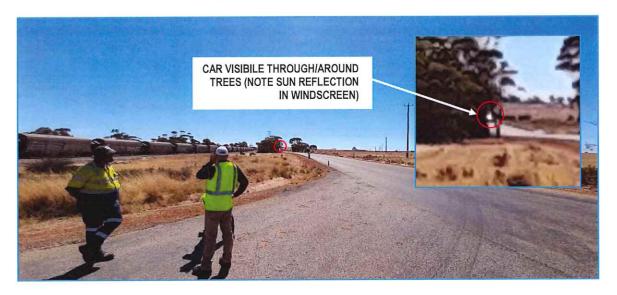
Towards the north, there is a minor obstruction to the sight line caused by the trunk of a tree. Refer to **Figure 12** and **Figure 13** which shows that the tree trunk is not wide enough to fully obscure the view of the car or the intersection, and there is a completely clear line of sight available immediately after the tree is passed.

Figure 12: Sight Distance Looking from North to CBH Access

Figure 13: Sight Distance Looking from CBH Access to North

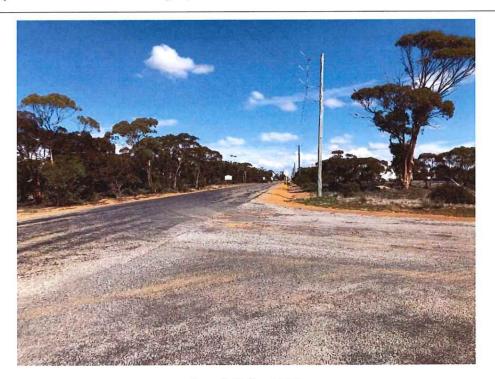
Figure 2: Finding 2.2, 2.3

There is evidence of pavement deterioration at the intersection due to trucks turning.

Flushing of the bitumen seal may result in reduced skid resistance and lower side friction which may contribute to loss of control where vehicles enter or exit the Cochrane Road and King Street intersection. Additionally, if intervention does not occur in an appropriate time frame, pavement defects may deteriorate to an extent that they adversely impact on vehicles being able to traverse the road safely.

Ref	Findings and Recommendations	Project Manager	ger			
		Agree /	Reason for Disagreeing	Proposed	Action	and
		Disagree		Comments		
2.3	Sight Distance - Vegetation Vegetation adjacent to the intersection adversely impacts on sight distance and may obscure a driver's vision of vehicles on the through road. This may increase the risk of right angle or right turn through crashes resulting in serious or fatal injury to vehicle occupants. Justification of the finding Vegetation adjacent to the intersection obstructs sight lines thereby increasing the risk to road users. Substandard sight distance may increase the risk of right angle or right turn through crashes and subsequent injury to vehicle occupants. Austroads Guide to Road Design Part 4A: Unsignalised and Signalised Intersections indicates that Safe Intersection Sight Distance (SISD) is the minimum distance which should be provided on the major road at any intersection. Using an operating speed of 70km/h and a reaction time 2.0 seconds the required Safe Intersection Sight Distance is 178m measured 5 m back from the holding line on the side road. Recommendation Remove vegetation from within the required sight triangles so as to provide SISD in accordance with Austroads Guide to Road Design. [IMPORTANT LOW]

Repair the defects and undertake ongoing routine maintenance to ensure that pavement defects are corrected at an appropriate intervention level.

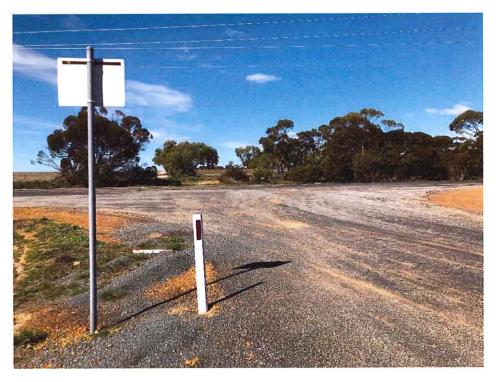
Figure 3: Finding 2.5

There is a risk of vehicles overshooting the intersection on account of the lack of hazard boards opposite the terminating leg of the intersection. This may increase the risk of rear end or right-angle crashes. *Australian Standard 1742.2-2009 Traffic Control Devices for General Use* indicates that sight boards comprising Unidirectional Hazard markers should be erected to face the stem of a T-intersection where approach speeds are high on the terminating leg of the intersection, and where standard intersection signposting would not provide sufficient warning of the intersection.

Review the need to provide terminating signage and if warrants are met make provision for hazard boards.

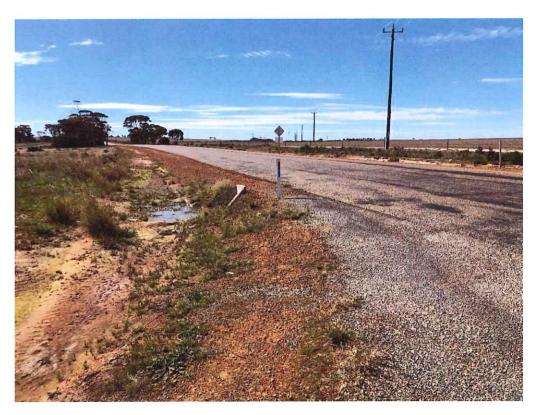
Figure 4: Finding 2.1

Should a vehicle inadvertently leave the roadway in the section of road adjacent to the unprotected culvert headwall a driver is likely to experience loss of control with the resultant crash causing serious or fatal injury. Austroads Guide to Road Design Part 6 indicates that the ends of culverts that cross under the road or are located parallel to the road constitute hazards if they are within the area of interest (e.g. clear zone). Road design should aim to eliminate all non-essential drainage features. Where drainage features are unavoidable, they should be designed as follows:

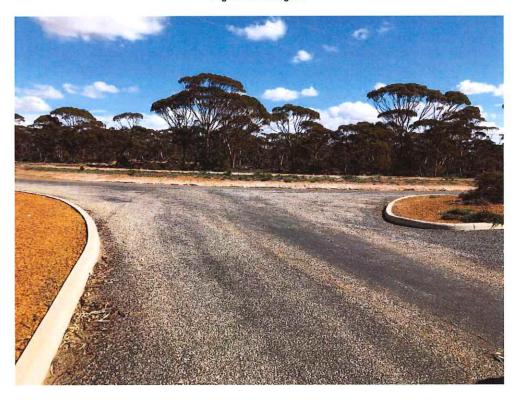
Figure 5: Finding 2.4

There are missing pavement markings and signs on both intersections audited.

Lack of intersection controls may result in a driver failing to recognise the road environment particularly at night or in inclement conditions. This may increase the risk of crashes with resultant injury to vehicle occupants.
