Shire of
Wongan-Ballidu

Special Meeting of Council
Tuesday, 9 April 2024

3.1 2023-2024 MOCARDY DAM MAINTENANCE

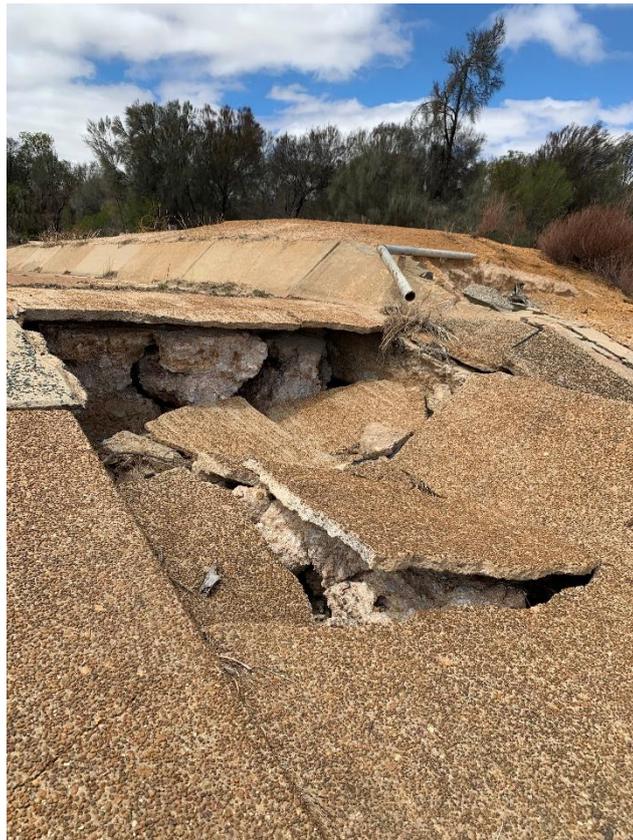
Mocardy Dam, constructed in the late 1950s and early 1960s, has suffered a notable failure in its inlet spillway, necessitating urgent attention. This failure presents immediate risks to the Shire's water supply and infrastructure, requiring prompt action to address the situation effectively. Failure to address this issue promptly may lead to further deterioration of the dam's condition and intensify the potential consequences for the Shire.

Damage to Existing Spillway

1. Draining of the dam: Firstly, the dam will be drained of water to facilitate repair works.
2. Engagement of civil contractor: A civil contractor will be engaged to carry out the necessary repairs. This includes removing the existing damaged spillway and conducting extensive repairs to the dam where it has washed out.

3. Sourcing of materials: Approximately fifty tonnes of bentonite will be sourced from Watheroo for the repair works.
4. Reconstruction of spillway: Once the damaged area has been prepared, a gravel layer will be placed over the top, and wing walls will be formed to direct the water flow.
5. Installation of Cementcrete Composite Blanket: Following the formation of the spillway, a Cementcrete Composite Blanket will be laid over the repaired area. It is anticipated that approximately two hundred square meters will be replaced. Additionally, the blanket will be anchored to the bank to ensure stability.

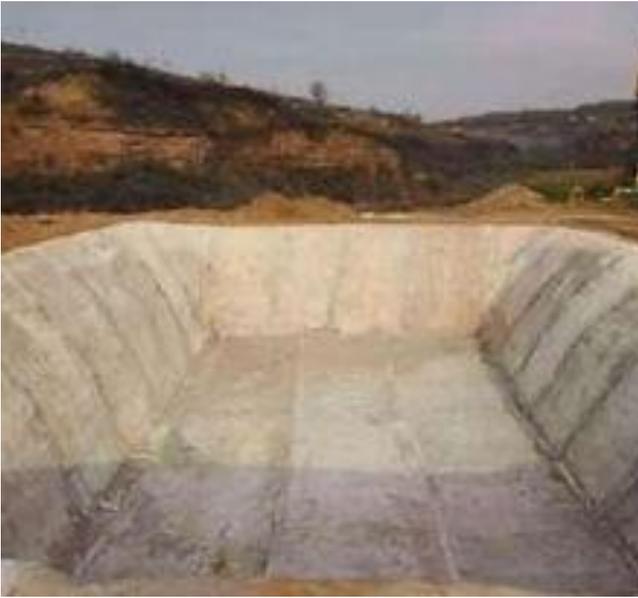
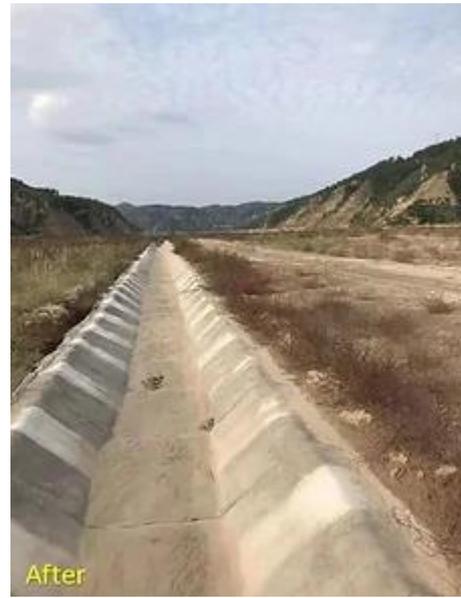
Cementcrete Composite Blanket is water hardening, corrosion resistance, erosion resistance and high temperature resistance. It has a fifty-year life expectancy.

Examples of Applications
