Special Meeting of Council Tuesday, 9 April 2024

3.1 2023-2024 MOCARDY DAM MAINTENANCE

The purpose of this report is to provide sufficient information summarising the repairs required at Mocardy Dam

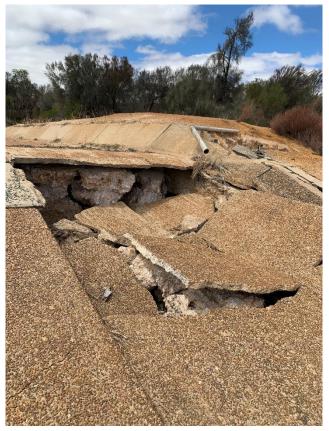
Mocardy Dam, constructed in the late 1950s and early 1960s, has suffered a notable failure in its inlet spillway, necessitating urgent attention. This failure presents immediate risks to the Shire's water supply and infrastructure, requiring prompt action to address the situation effectively. Failure to address this issue promptly may lead to further deterioration of the dam's condition and intensify the potential consequences for the Shire.

Damage to Existing Spillway

- 1. <u>Draining of the dam:</u> Firstly, the dam will be drained of water to facilitate repair works.
- 2. <u>Engagement of civil contractor</u>: A civil contractor will be engaged to carry out the necessary repairs. This includes removing the existing damaged spillway and conducting extensive repairs to the dam where it has washed out.

- 3. <u>Sourcing of materials</u>: Approximately fifty tonnes of bentonite will be sourced from Watheroo for the repair works.
- 4. <u>Reconstruction of spillway:</u> Once the damaged area has been prepared, a gravel layer will be placed over the top, and wing walls will be formed to direct the water flow.
- 5. <u>Installation of Cementcrete Composite Blanket:</u> Following the formation of the spillway, a Cementcrete Composite Blanket will be laid over the repaired area. It is anticipated that approximately two hundred square meters will be replaced. Additionally, the blanket will be anchored to the bank to ensure stability.

By implementing these measures, we aim to effectively repair the spillway and restore the functionality and safety of the dam.

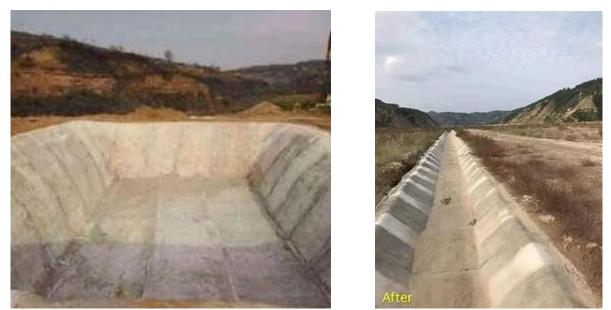
Cementcrete Composite Blanket is water hardening, corrosion resistance, erosion resistance and high temperature resistance. It has a fifty-year life expectancy.

Examples of Applications
